# Environmental Exposure Report

## Depleted Uranium in the Gulf

Bernard Rostker  
Special Assistant for Gulf War Illnesses  
Department of Defense

Last Update: July 31, 1998

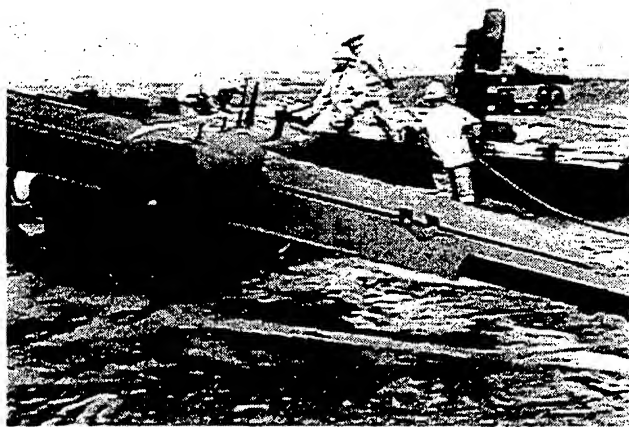
Figure 23 – Crashed A-10 at KKMC

An A-10 aircraft reportedly crashed and burned while trying to recover at KKMC.<sup>138</sup> The crash could have exposed emergency response personnel (firefighters; security policemen, rescue personnel) to smoke and DU oxides from burning 30mm DU rounds carried as part of the A-10's combat ammunition load. In addition, cleanup crews might have been exposed as well, if they did not wear proper personal protective equipment. This case is under investigation.

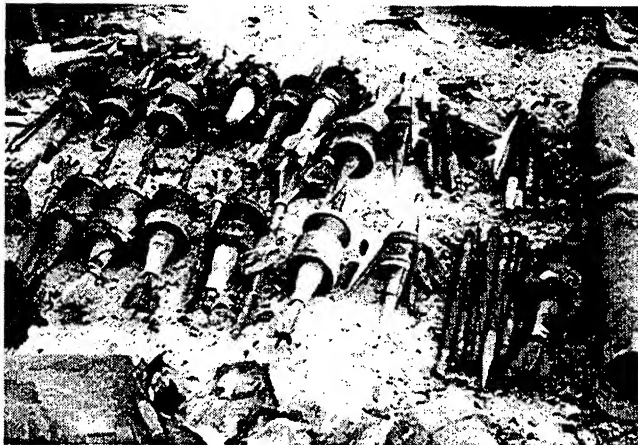
Figure 33 - DU rods collected at Doha

EOD troops were aware of the presence of DU and were familiar with the potential hazard that it posed. More importantly, they were trained and equipped to detect DU contamination. Their initial survey, which was limited due to the quantity of UXOs in the North Compound, found very little DU outside the immediate vicinity of the three destroyed tanks.<sup>221</sup> The standard uniform for UXO clearing was a flak jacket and kevlar helmet, with gloves worn when debris was moved. Because of the extreme heat, only T-shirts were worn under the flak vests. EOD and combat engineer troops (and later, line

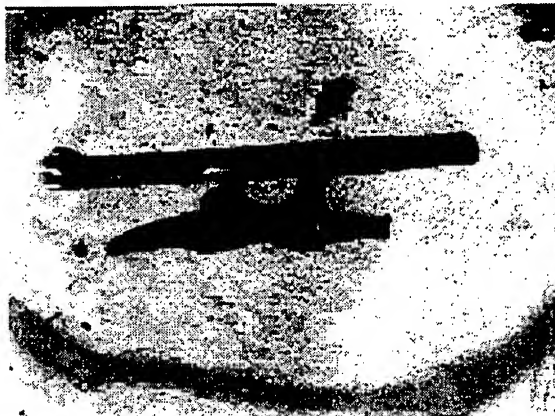
Figure 35 - Marked DU rod and sabot

The cleanup plan for the North Compound involved EOD personnel working together with the 58th Combat Engineering Company to find, mark, render safe, and remove UXOs. The former 146<sup>th</sup> Ord. Det. (EOD) Commander states that "Engineers didn't pick up any DU unless an EOD guy told them to." EOD marked the DU rounds they found with orange spray paint, painting a circle around the penetrator, and wore leather gloves to pick them up. Exposed DU penetrators were wrapped in heavy plastic and put in wooden boxes or 55-gallon drums. Later, after the AMCCOM Radiation Control team had arrived at Doha, the DU was placed inside one of the destroyed tanks for

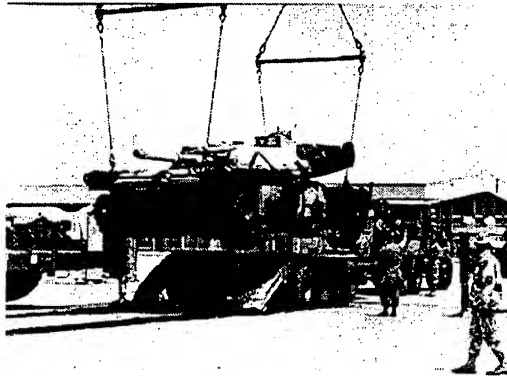
Figure 42 - Removing burned M1A1

Following the removal of the contaminated M1A1 tanks and the departure of the AMCCOM and CECOM teams on August 2, a hiatus in Radiation Control and cleanup activities ensued for several weeks. The only activity that took place in the North Compound during this time frame was in the supply area several hundred meters away from the 2<sup>nd</sup> Squadron motor pool area, which had been cleared earlier of UXOs thrown into the area by the July 11 explosions. No ammunition was stored in this location, and no DU was found in or near this area.
